Portfolio

Matthew Migliozzi

Matthew Migliozi's Portfolio

Works from: Arlington National Cemetery, National Park Service,
& Personal Projects, August 2022 to November 2023

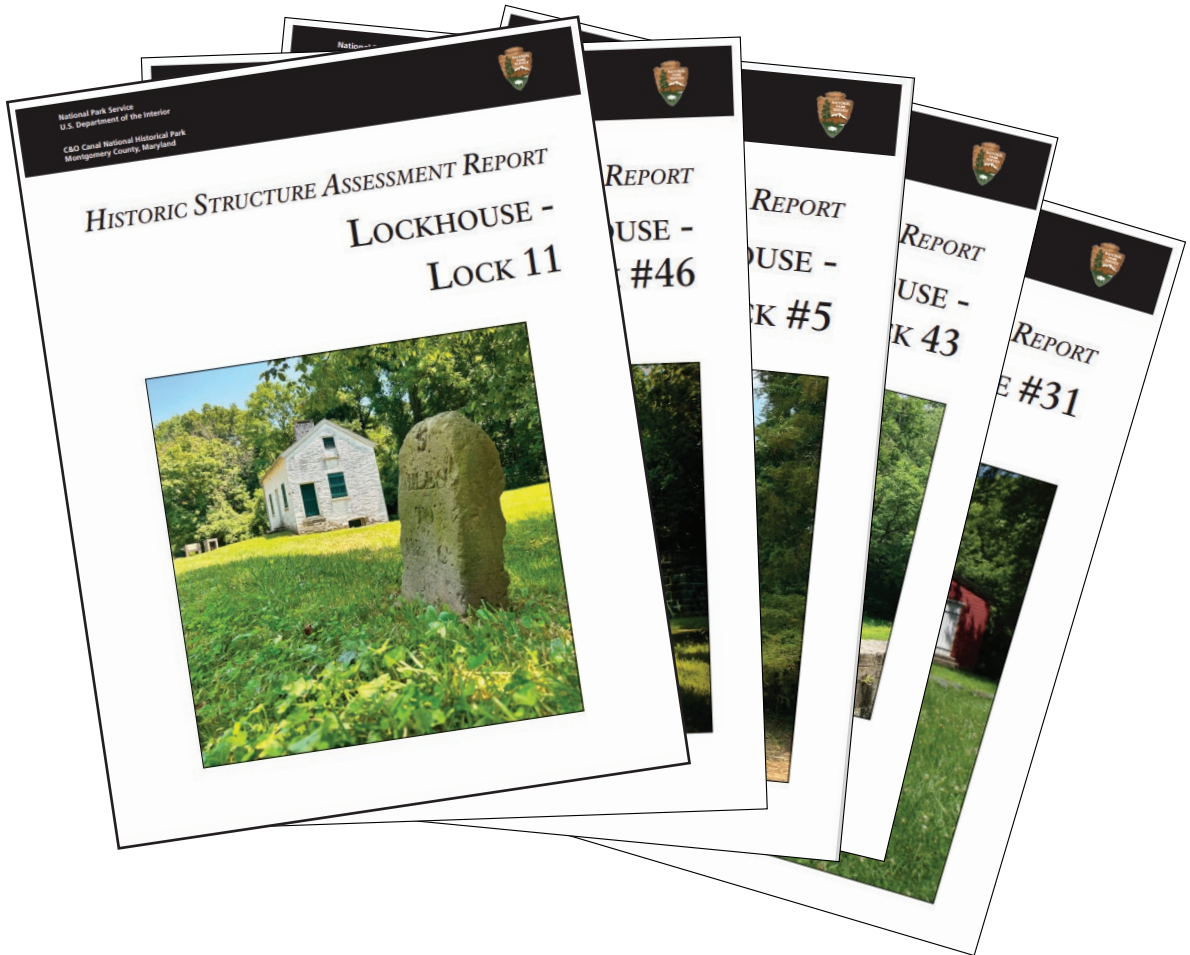
Each of the five Historic Structure Assessment Reports include five of the following chapters + appendices: HSAR Table of Contents

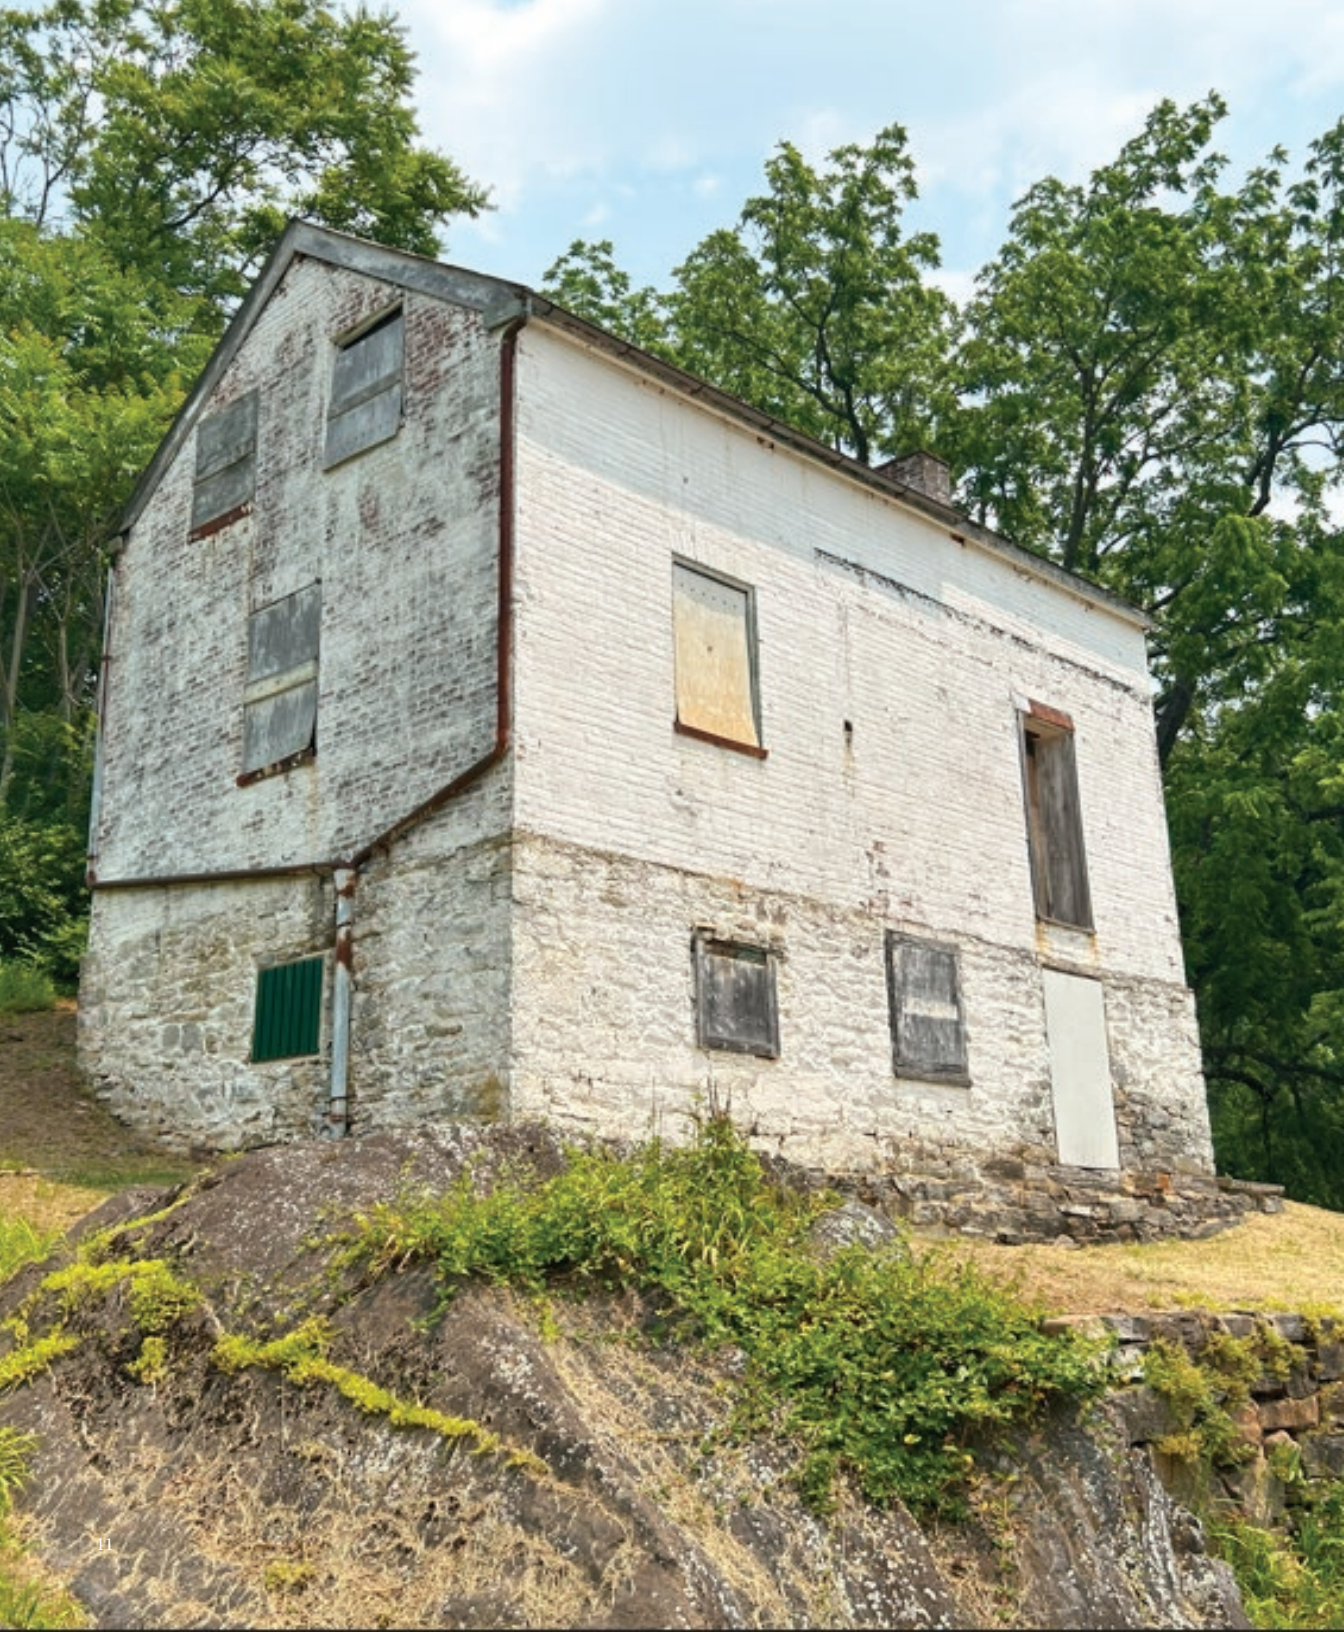
1
A1 ——— NORTHEAST ELEVATION
SCALE (A)

Lockhouse – Guard Lock #5 is a simple one-and-a-half story, gabled-roof structure constructed in 1837. The structure consists of a 33'x19' bluestone foundation within a hillside that is visible by a fraction of a foot on the north-east elevation and becomes increasingly visible through the rear. Exterior walls are laid in a common bond pattern with a painted white limewash finish. The roof is finished with ribbed steel sheet metal. The structure includes one end gable brick chimney on the southeast façade. Lockhouse – Guard Lock #5 has a footpath access to the northeast, but it is currently overgrown with grass and vegetation. The structure sits on the crest of a hill overlooking the C&O Canal Inlet Lock 5. The building has an open and heavily sloped landscape on the northwest, southeast, and southwest façades. It is encroached upon by large trees, small shrubs, and overgrown vegetation. The building has no additions, but once included a porch structure on the southwest façade overlooking the inlet lock.

The lockhouse at Guard Lock #5, located in Ashton, Washington County, Maryland at mile 106.80 on the C&O Canal Towpath, is elevated on a rocky berm about 20 feet beyond the flume and at the upper end of the lock. The design of the lockhouse at Guard Lock #5 is consistent with the chief engineer's specifications; it is one and a half stories tall with stone foundations and limewashed brick. The formerly wood shingle roof has been replaced with galvanized metal. A covered and enclosed basement porch on the canal side and a first floor porch on the lock side have been removed. A small, covered wood porch with steps would have been necessary to access the main door on the lock side (Northeast elevation).

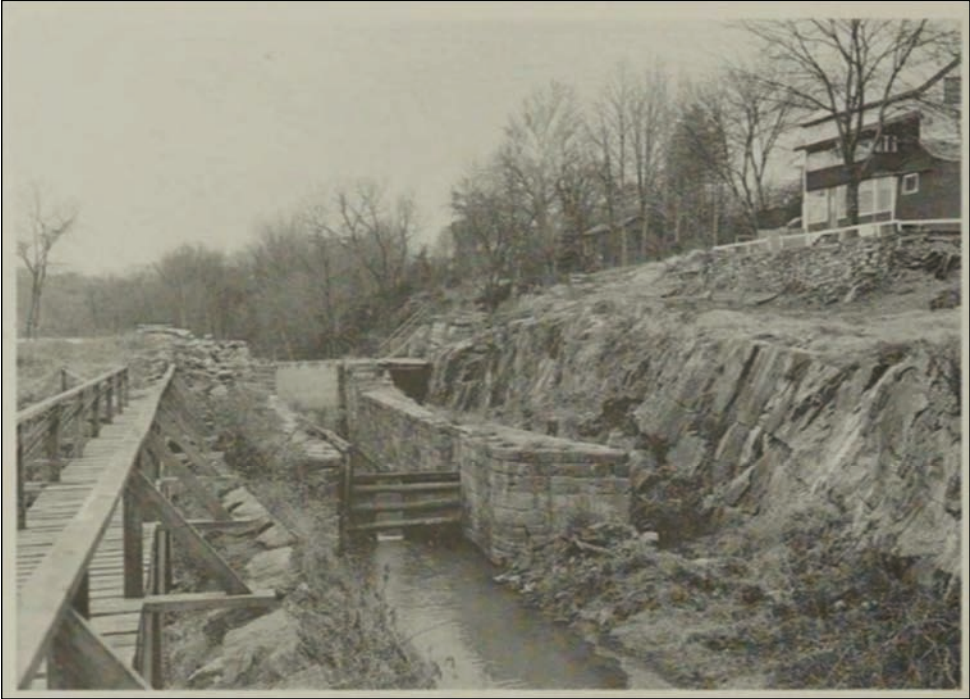
Figure 6. Inlet Lock 5 at Dam 5, C&O Canal, Fort Frederick Vic, Maryland (106.8 miles). Jack E. Boucher, photographer, 1959. P & P, HABS, MD, 22-FOFR.V, 5-1.

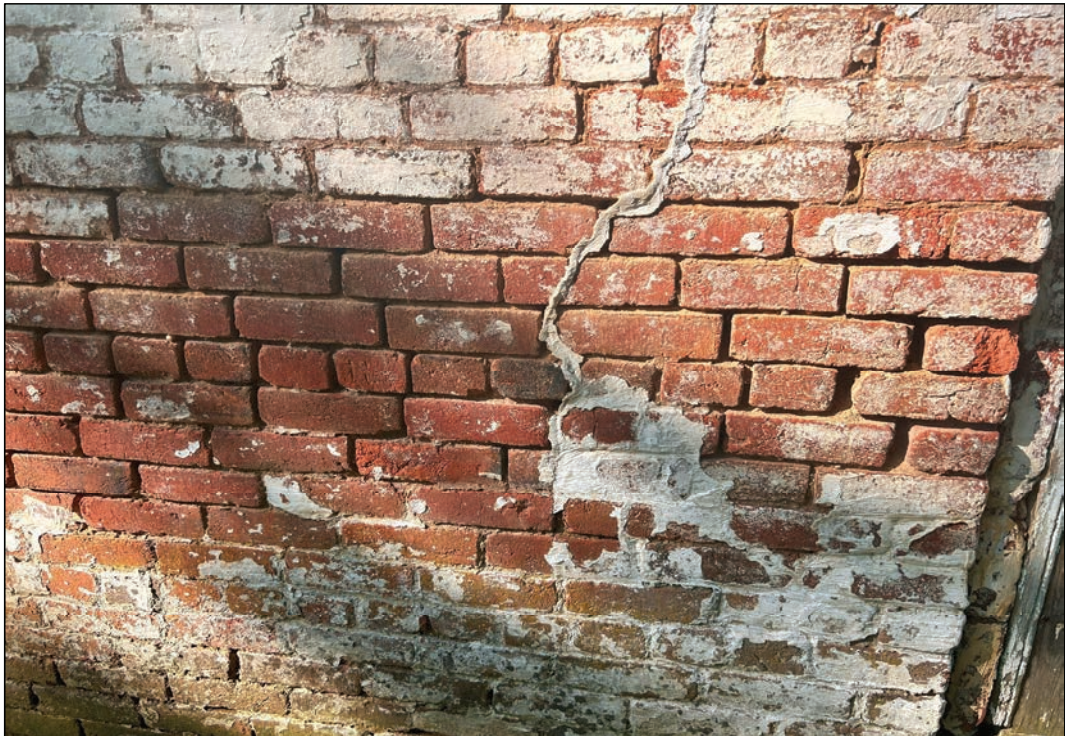
Figure 37. Northeast Elevation Common Bond Brick Wall. Note Deteriorated limewash and mortar failure. -

Common bond brick exterior walls are in stable condition, but mortar is missing or in poor condition throughout. Mortar failure as well as limewash deterioration was possibly caused by water runoff due to failing and missing gutters on the southwest and northeast elevations.

The exterior walls are compromised of brick laid in a common bond pattern and finished with a limewash coating. Fairly common for C&O Canal lockhouses, as well as for typical residential houses built before 1840,²¹ evidence remains of a historic porch that had been located on the southwest elevation of the building.

B Shell	B20 Exterior Enclosure	<i>B2010 Exterior Walls</i>	FAIR	CRITICAL
<p><i>B2010 Exterior Walls</i></p> <p>There is evidence of missing mortar, cracking, and paint deterioration.</p> <p><u>Surfaces</u></p> <ul style="list-style-type: none"> Wash exterior wall surfaces to prevent accumulation of dirt or other deposits. <p><u>Masonry Joints</u></p> <ul style="list-style-type: none"> Repoint eroded, cracked, or missing joints. <ul style="list-style-type: none"> Rake out joints by hand, generally avoiding rotary saws or drills, to a depth of 2½ times the width of the joint (or until sound mortar is encountered), to ensure new mortar will stay adhered between the masonry units. Repoint joints using a lime-based mortar and match historic mortar in color, texture, width, and tooling. Ideally the new mortar should match the existing mortar in strength but, at minimum, it must be slightly weaker than the adjacent masonry. A mortar analysis is suggested. See NPS Preservation Brief #2. <p><u>Cracking</u></p> <ul style="list-style-type: none"> For masonry walls, cracks should be repaired using an appropriate mortar mix. Cracks not ultimately elected for repair should be monitored with crack monitors to determine if there is any movement Restore limewash coating. <ul style="list-style-type: none"> Identify an appropriate limewash recipe. Remove loose coating to a sound substrate. Sand or gently roughen the surface for a good bond. Wipe clean. Remove deteriorated caulks and sealants, clean, and reapply appropriate caulks and sealants using backer rods as needed. Follow manufacturer's instructions regarding preparation and installation. Ghosting on the rear wall should be considered for preservation to demonstrate the former implementation of a wooden porch overlooking the inlet lock. See <i>NPS Preservation Brief #17 Architectural Character</i>.

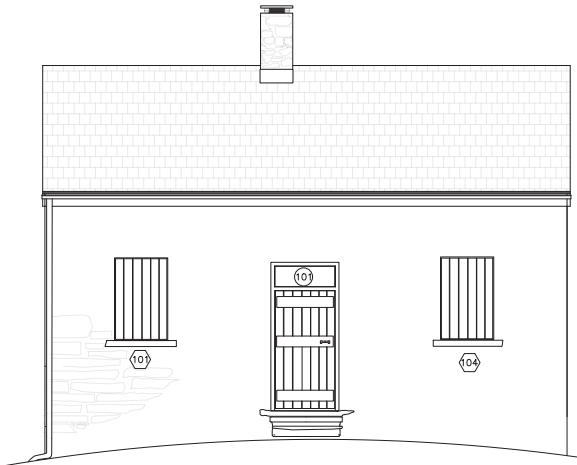
1 North Elevation
A1 SCALE (A)

The lockhouse serving Lock 11 is a simple one- and a half story masonry building. Constructed in 1830, the 30'x18' lockhouse was built atop a light neutral slope overlooking the red sandstone canal lock. The structure walls are built with cut bluestone with a painted white limewash. The structure is protected by a modern, historically sympathetic wood shingle roof that includes a modern cut stone chimney. In the surrounding landscape, both the lock and the lockhouse are encroached upon by vegetation and trees. Separating the lockhouse and the lock is a pedestrian towpath. The closest vehicle access is located at Lock 10.

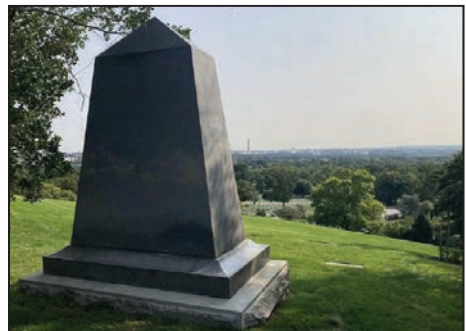
The memorial features an Egyptian-style obelisk with a two-part stepped base. The lower part of the base is heavily rusticated, with a neatly squared-off top edge; this was created with a tooled margined edge to achieve quarry-faced rustication. The base of the obelisk, specifically the plinth, has an elongated concave curve (cavetto) that matches the smooth finish of the obelisk. Both the obelisk and the base are made of moderately toned gray granite. The finish of the obelisk and the two-part base was hand-honed, possibly fine-rubbed, to a soft matte reflective surface. The cast bronze bas-relief sculpture depicts a three-quarter profile bust of Sheridan encircled by a wreath of palm fronds and buckeye leaves.

General Philip H. Sheridan Memorial looking east towards Washington D.C. Photo: Matthew Migliozi, 2022. ANC.

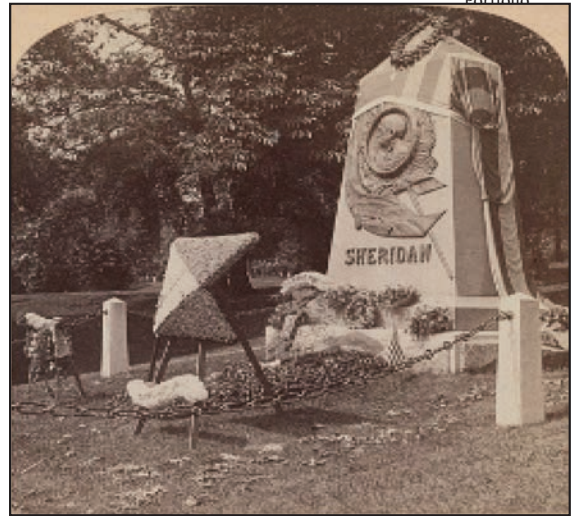
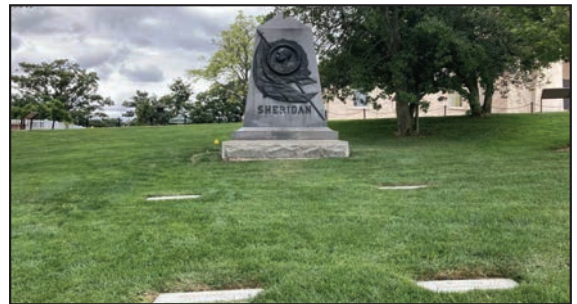
Sheridan Memorial Grave decorated with wreaths and American flag. Note the historic bollards, 1893. Library of Congress, #2018653122.

Since the creation of the Sheridan Memorial Grave, its landscape and contributing features have undergone minor changes. Most notably, a set of bollards and a dirt pathway have been removed. The dirt pathway led directly to a walkway that still goes through the east lawn of Arlington House. Sheridan's gravesite occupies a 50-foot radial plot line so that no others besides him and his family may be buried there. Since his burial, D.C. architect Pierre L'Enfant, General Horatio Wright, and President John F. Kennedy have been interred in close proximity. After Sheridan's death, his daughters and wife were interred in his plot. His wife Irene Rucker Sheridan was buried in 1938, and daughters Mary, Irene, and Louise were buried in 1959, 1964, and 1969, respectively.

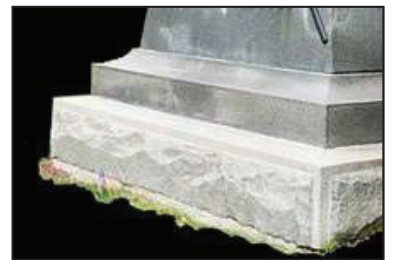
Obelisk

Bas Relief

Rusticated Base

Two- Stepped Base

GENERAL PHILIP H. SHERIDAN MEMORIAL GRAVE CHARACTER DEFINING FEATURES

These are the visual aspects and physical features of a historic site that need to be preserved and protected. Character-defining features comprise the appearance of every tangible cultural resource and include the overall shape, features, materials, craftsmanship, decorative details, related spaces and sequences of spaces, and aspects of the site and environment. The National Register qualities of location, design, setting, materials workmanship, feeling, and association are also included and must be preserved.

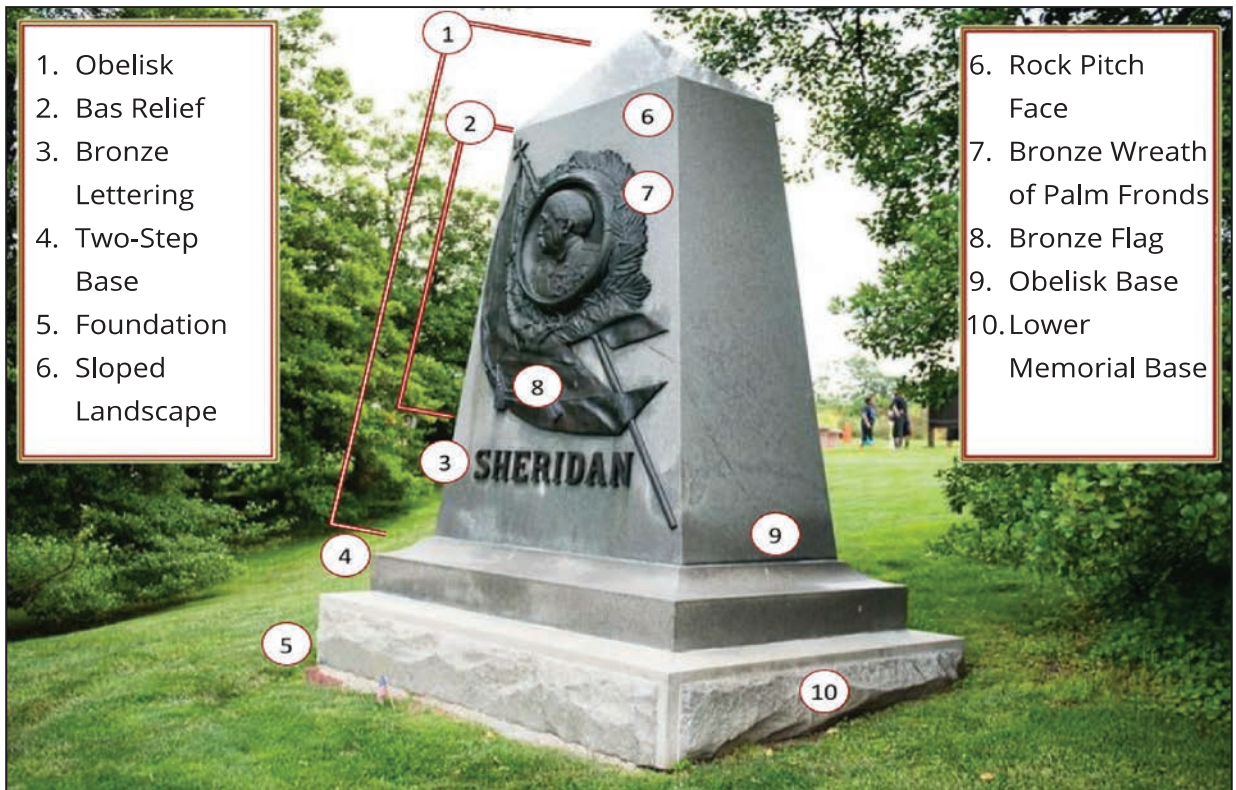
General Philip H. Sheridan Memorial Grave Character Defining Features Figure. Matthew Miglozzi, 2023. ANC/HPTC.

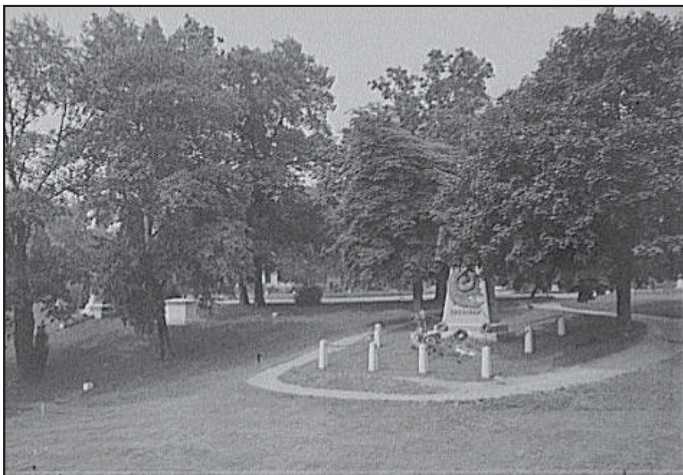
General Sheridan's Memorial Grave with dirt path and bollards, Undated. Photo: ANC Historical Collection.

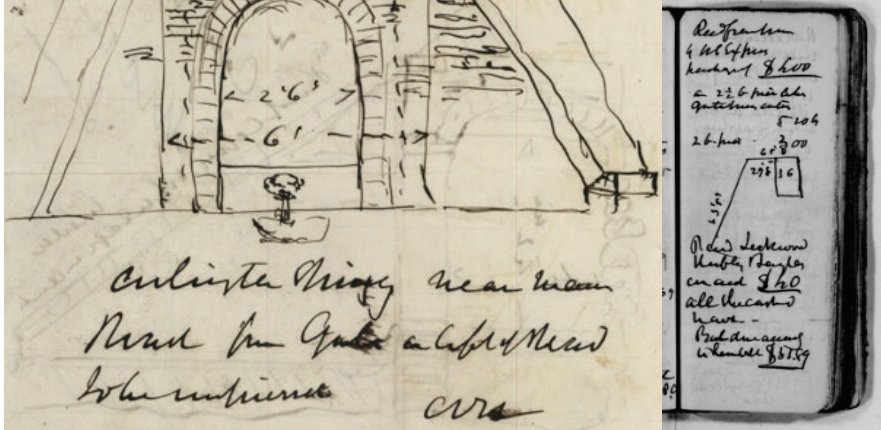
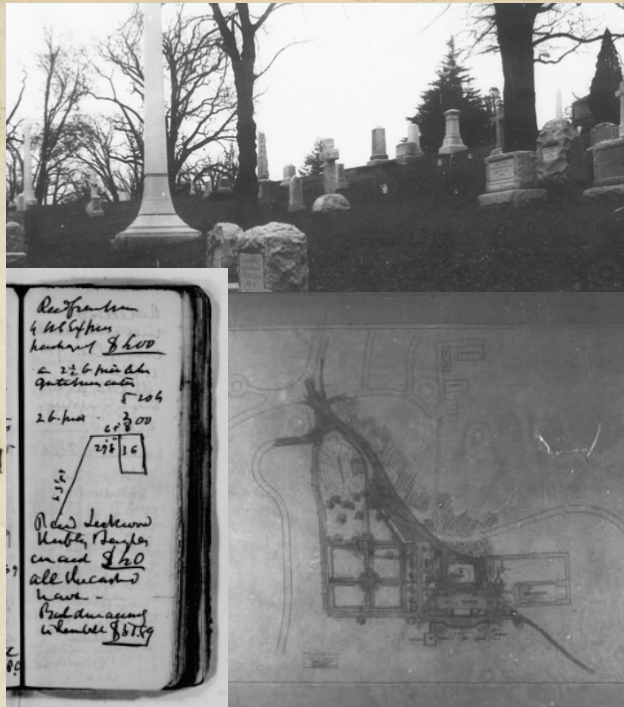
Section's 1 and 2 Survey - Digital Format Creation

While at Arlington National Cemetery, there was an unprecedented and new need to conduct condition assessments on thousands of cultural resources in the cemetery's Sections 1 and 2. These resources were private, non-governmental grave markers that took on various shapes and sizes.

A two person team, including myself and my fellow intern, ambitiously created a new format system of entry for cultural resource data for new, undocumented resources. These came in the form of private markers, which differ from the standardized government funded headstones at military cemeteries. Sections 1 and 2 at Arlington National Cemetery hold the predominant amount of private markers in the cemetery and range in styles, material, and condition.

Partial Screenshot of Condition Assessment Fillable Form

Partial Screenshot of Condition Assessment Raw Data Table

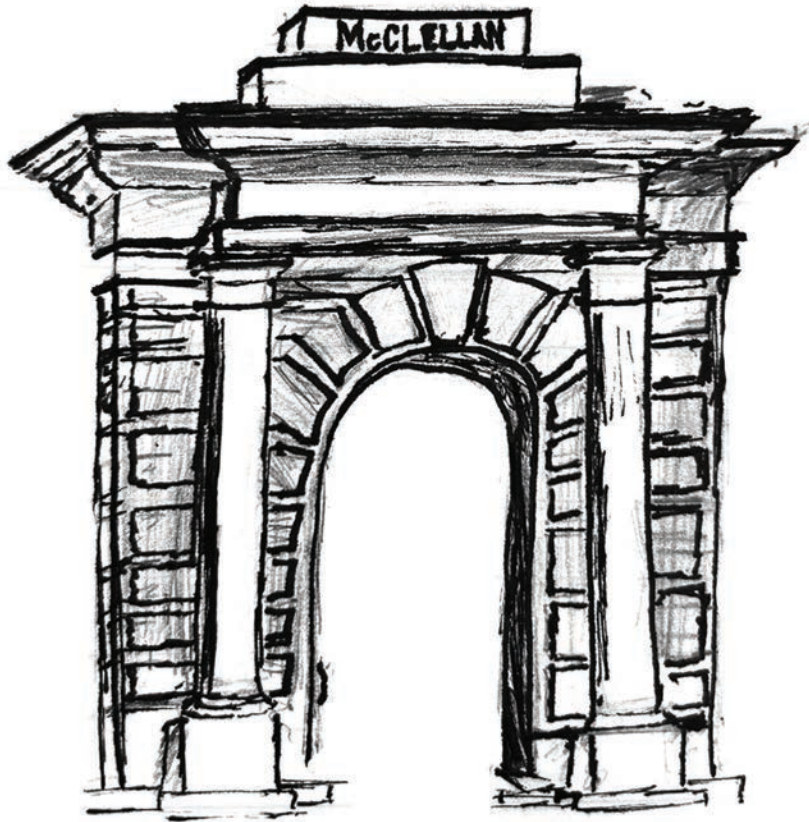
In the Field Sketch of McClellan Gate
Arlington National Cemetery
August 2023

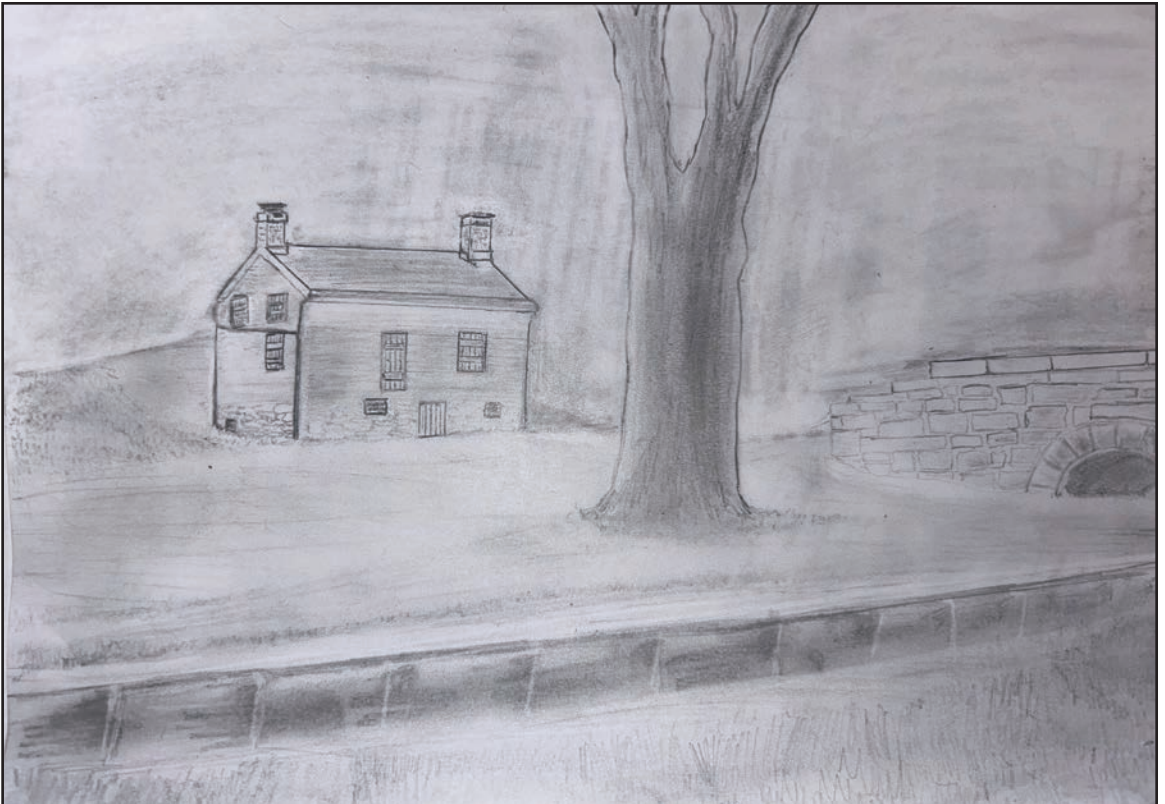
Lock #46 Hand Drawing
Chesapeake and Ohio Canal
July 2023
